The Dacian Fortress of Căpâlna (Săsciori Commune, Alba County) – In Search of Lost Time (1999–2019)

The present paper deals with a recovered hoard of gold Hellenistic style jewellery, stolen in 2001 from the Dacian fortress of Căpâlna, archaeological site and UNESCO monument from Romania. After 7 years of illegal trafficking of the artefacts on the black market of antiquities, the Romanian law enforcements recovered the hoard from Germany, with the generous support of an expert from Frankfurt am Main. The items come from a Western Balkan workshop around the inhabited by the Danubian Celts, located on the northern territory of Serbia and the western part of nowadays region of Banat (Romania). Nevertheless, one should not completely exclude the possibility that the items were made in a roving workshop on the territory of South-western Dacia. The technique used and the style of decoration prove the assimilation of late Hellenistic and Italic influences. The composition of the gold alloy is similar to the one used by jewellers in the late Hellenistic and Roman imperial periods. An important detail is the reconstruction of the "discovery circumstances" inside of the protected area of C

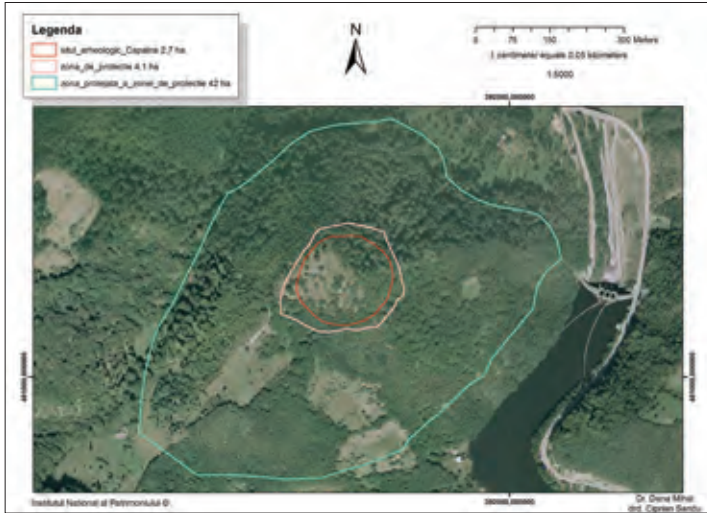
Figure 1. Aerial view of the Dacian fortress of Căpâlna, indicating the site, the protection area and the protected area. (Sursa: I.N.P. Raport de monitorizare cetăți dacice <http://patrimoniul.gov.ro/images/monitorizare/Cetatea-dacica-de-la-Capalna-zona-de-protectie.jpg>).

The Dacian fortress of Căpâlna lies in the Sebeș Mountains⁵, part of the Șureanu Mountains, somewhat peripheral within the Dacian fortification system of the Orăștie Mountains. Included in 1999 on the World Heritage List of Sites (UNESCO), together with the other 5 similar fortifications from the Hunedoara district⁶, the fortress of Căpâlna is easy to approach, being located very close (ca. 2 km) from DN67C (Transalpina Road), on a road difficult to access to off-road vehicles (on Gărgălău valley, to the north) or on a pathway, to the south (Râpa stream) (Figure 1).

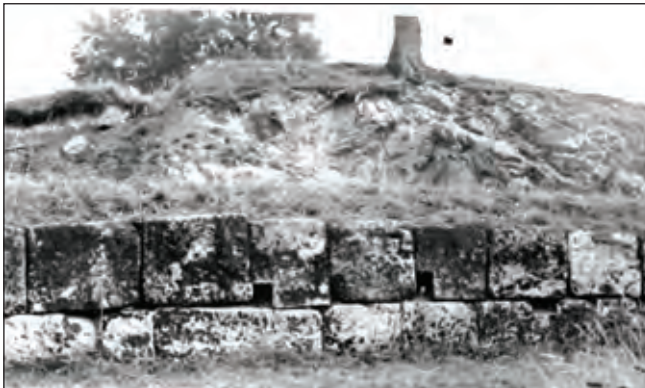
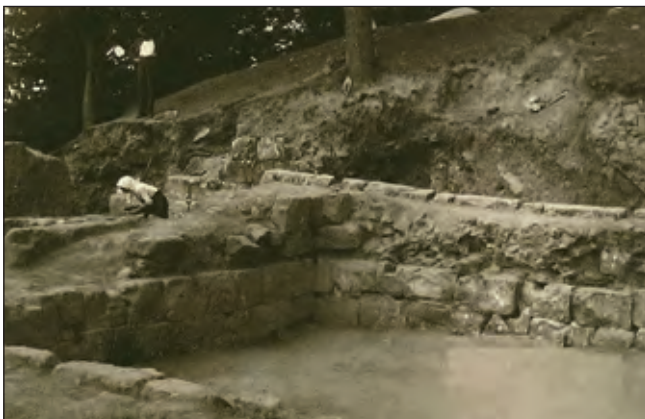
Figure 2. Details during the archaeological excavations (Glodariu and Moga 1989).

portion of its secrets, however sufficient enough for the interested to know that it belonged to above system of the Dacian Kingdom in its classical period (1st century BC – early 2nd century AD), that it had been built sometime by the end of Burebista's reign (or just after), that its walls had been erected according to the same technique as identified in the contemporary fortress of Costești-*Cetățuie*, that it lay in a dominant, strategic, barely accessible position, monitoring the Sebeș valley and communication southwards, to Polovragi (Glodariu and Moga 1989: 126-130; Glodariu and Moga 2006: 142-146; Pescaru and Pescaru 2009: 47-51), making easy connection with the fortress of Tilișca, eastwards and that of Cugir, westwards, that the access to the fortress had been flanked by two rectangular towers (a tower house and a gate tower) (Figure 2), that it was provided with a central acropolis, on a relatively rectangular rock platform and a temple on the south-eastern terrace. It was first hypothesised that the fortress had been conquered in the first Dacian War by the cavalry of Lucius Quietus⁷ - who would have also conquered the fortresses of Tilișca and Cugir - to be later partially dismantled, and hastily rebuilt during the second War, only to be put to fire by the conclusion of the wars (Glodariu and Moga 1989: 126-130; Glodariu and Moga 2006: 142-146; Borangic 2017: 132-134). Ultimately, the fortification (or what remained of it), was reused in the Middle Ages, likely as an observation post (Figure 2)

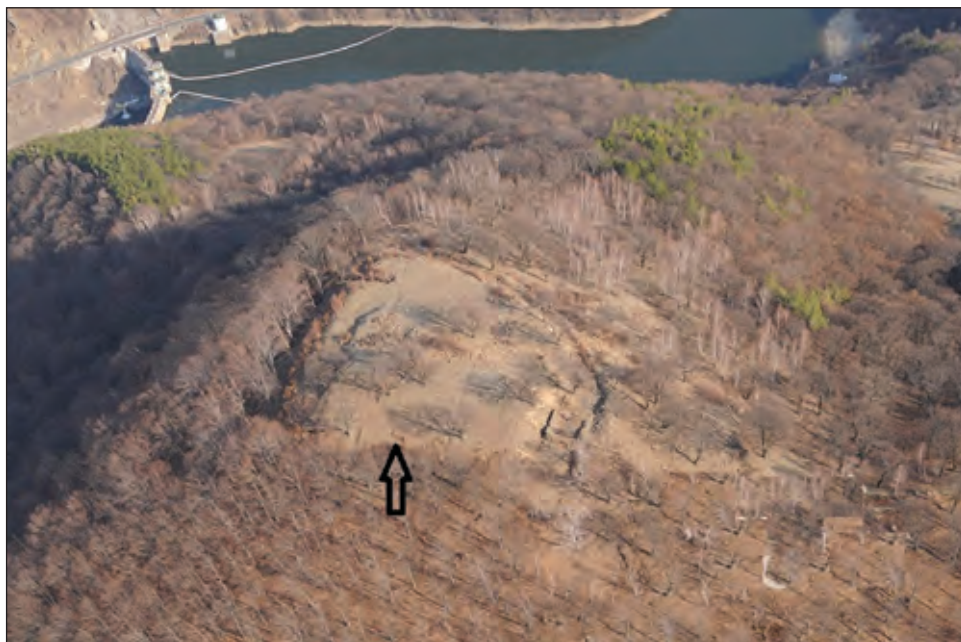
Figure 3. Aerial view of Căpâlna fortress, northwest. The arrow indicates the large poacher's pit (2001), still visible (Photo Zoltan Czajlik, MNIT).

investigated in relation with the suspected archaeological poaching, which resulted in the discovery of an iron tools deposit. Practically, since the past century or otherwise put, before it became a UNESCO site, in the fortress no further archaeological investigations had been performed (Figure 3).

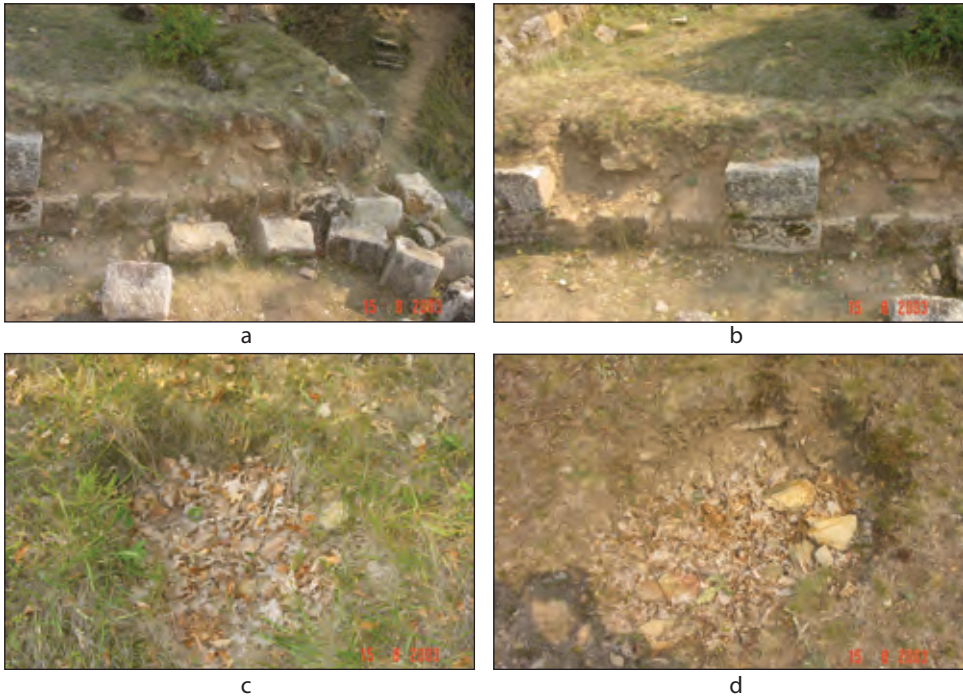
Figure 4. Photos taken in August 2003: the wall of the dwelling-tower collapsed (a-b); pits dug by poachers (c-d) (photo by R. Totoianu).

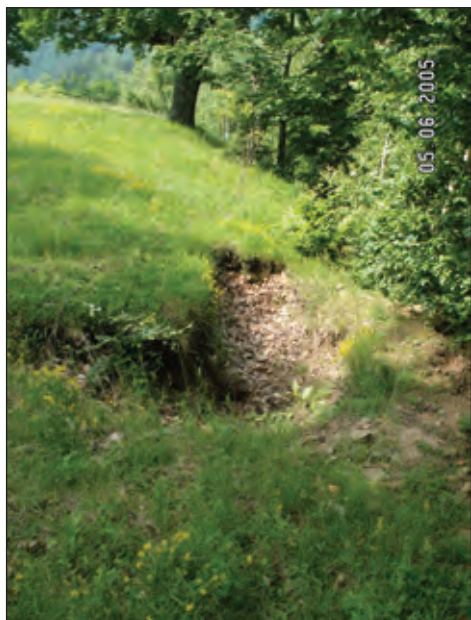
Figure 5. The poaching pit reported in 2001 (photo by R. Totoianu, 2005).

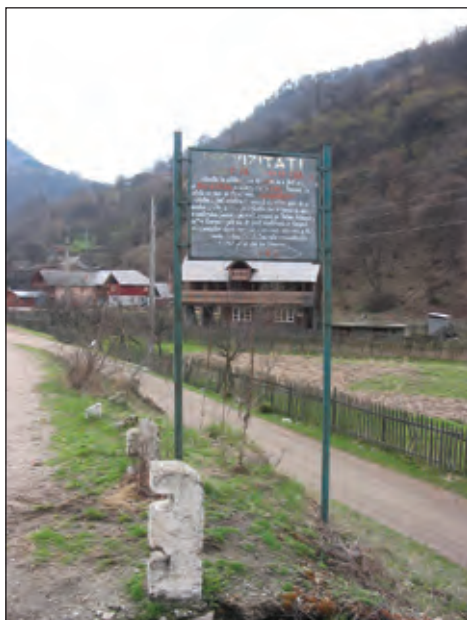
Figure 6. Signboard of the access road to the fortress (photos by M-M Ciută, April 2006).

of the hill on which the fortress is placed, in the vicinity of the junction with the road climbing to the fortress, there was a panel, rather worn and torn, which mentioned, in a poorly legible text, partially erased, that at ca. 2 km ahead there lay a Dacian fortress is located (Figure 6).

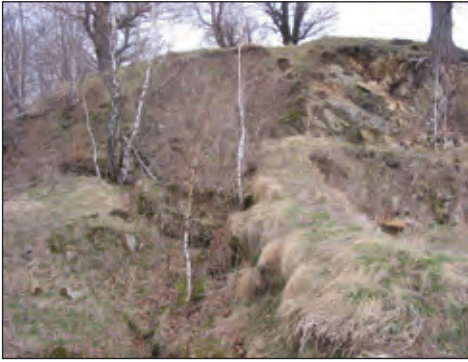
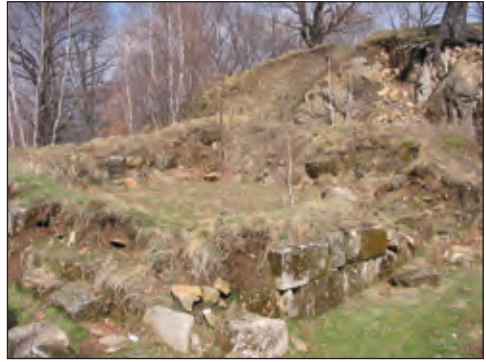
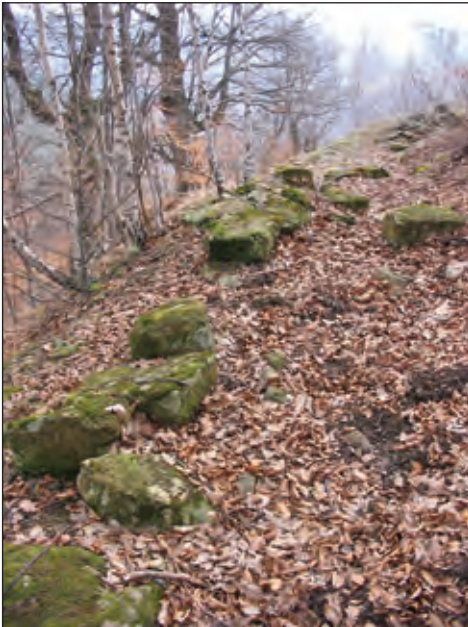
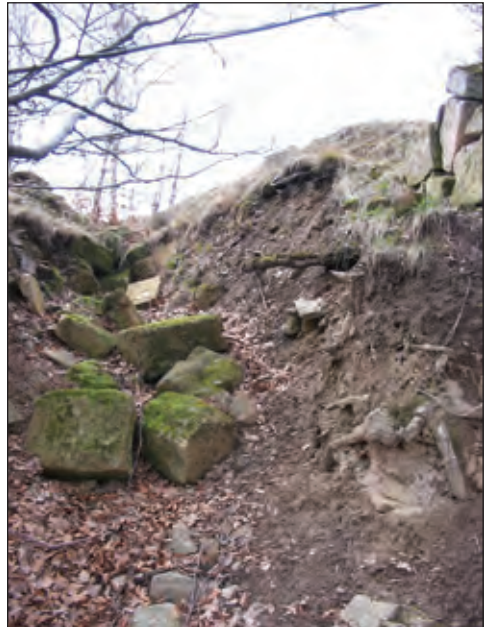
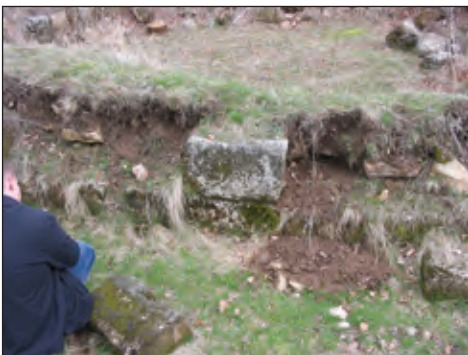
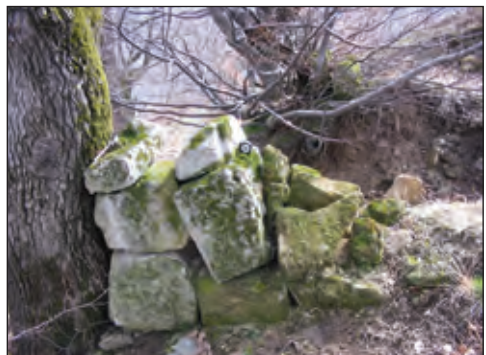
¹² “Still on the occasion, it was noted that important parts of the fortress walls had been vandalised, stone blocks being dislodged from their original position and thrown to the ground” – excerpt from case file 130/P/2006 (see Figure 7).

The archaeological site, strongly "vandalised", appeared in a deplorable state. The second row of the tower house wall was collapsed here and there, more than 10 sucked in blocks being dislodged and collapsed by its base. The earth they sometimes contained had slid inside and outside of the wall, the same case is noted also in the enclosure wall of the fortress, below which lay a road circumscribing the fortress top has extended. In several places, the worked blocks were collapsed on the road and some were rolled past it, stopped in various positions on the steep slopes with eastern, southern and northern exposure. In the eastern sector, a few blocks were removed from their original position and rebuilt in a curious manner, perpendicular to the fortress's wall route, being supported by a noble tree. Such layout evidenced that the individuals involved in their destruction had plenty of time and resources available.

Figure 7. Destruction of curtain walls and tower walls inside the fortress (photos by M-M Ciută, April 2006)

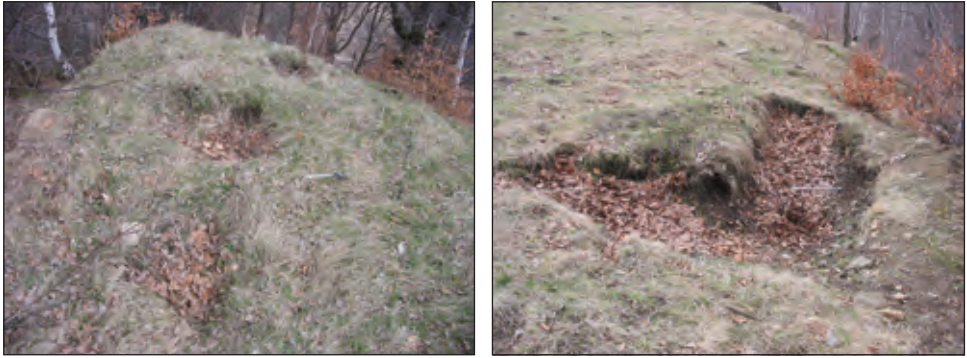
There were noted frequent, variously sized holes (more than 100), older or more recent, based on how they were covered by leaves or vegetation, spread on the entire surface of the fortification as well as just nearby it, on the manmade terraces towards north-east and south-east (Figure 8). Some, older ones, were clogged, others, more recent, covered only by leaves. The poaching hole excavated in 2001 (Figure 8/b) could also be recognized. There were also identified holes covered by topsoil, to hide illegal excavations, indicative

Figure 8. Pits of archaeological poaching identified inside the fortress (photos by M-M Ciută, April 2006)

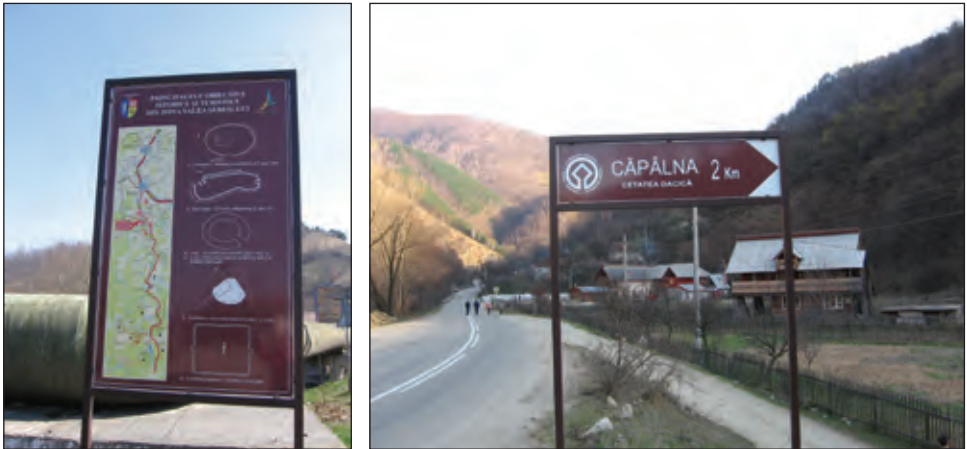
Figure 9. Signage marks on the objectives on the Sebeş Valley (left) and indicator of the road to the fortress of Căpălăna (right) (photos by M-M Ciută 2007)

The legal investigations required repeated visits on-site, in the fortress of Căpâlna, to identify additional evidence for the criminal case as well as to reconstruct the circumstances in which the detectorists carried out their illegal detecting activities there. Thus, during the visit in March 2007, accompanied by employees of D.J.C. Alba¹⁴, we noted new elements in how the site and historical monument were made known. Thus, after the actions of the County Council of Alba and specialized departments, some information and signalling panels were set up. The first was placed in the centre of Săsciori commune, to the left of Transalpina Road, with information on the *main historical and touristic sites on the Sebeş valley*. Coloured according to historical site markings, the panel is both generous in information and efficient, being set in a highly visible place (Figure 9).

Further on, we noticed that the panel with illegible text had disappeared, being replaced by a sign for the road to Căpâlna-Cetățuie, the conventional symbol finally referring to a UNESCO site (Figure 9). The access road was no different from the previous year, yet, by the entrance to the fortress from the Șaua Stăiunilor, we were pleasantly surprised to find a direction panel, with excellent details regarding the site as well as the most representative results of the archaeological excavations conducted there, inspiringly completed by the topographical layout of the fortress with the mention of the main elements of military architecture, respectively indicating the stages of the archaeological research. Furthermore, the panel informs that the site is listed among both the *Historical Sites* (LMI) and the World Heritage UNESCO sites (Figure 10). Thus, no one could ever say, to their defence that they were unaware of being in an archaeological reserve, protected by national and worldwide regulations when carrying activities forbidden by the criminal law concerning the protection of the national cultural heritage.

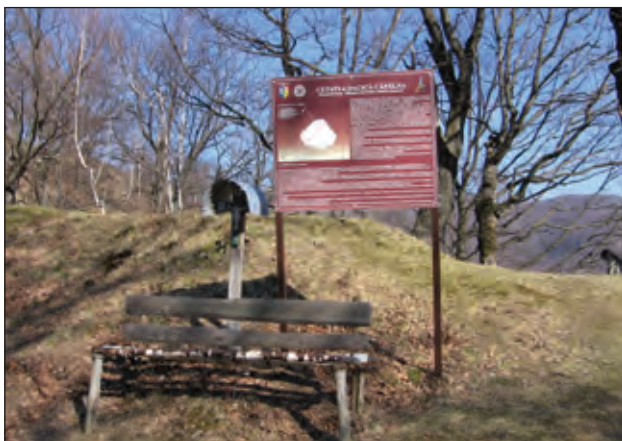
Figure 10. The indicator panel at the entrance to the fortress, with the topographic plan of the fortification, the archaeological research units and the related explanations (photo by M-M Ciută, 2007).

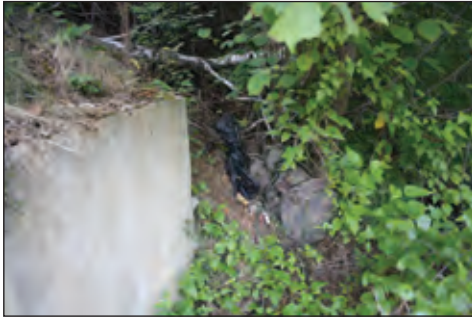
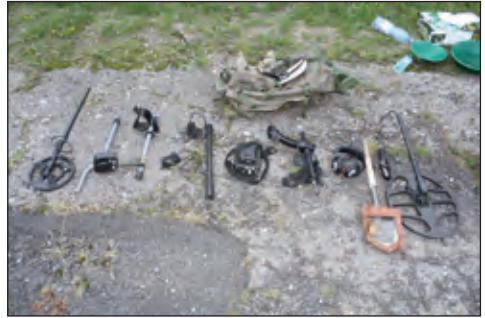
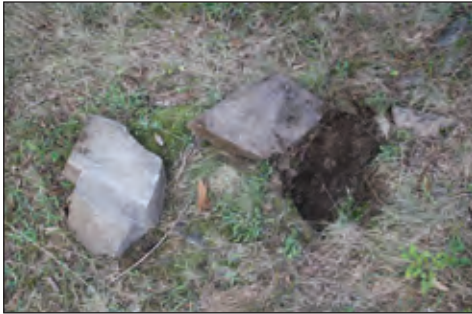
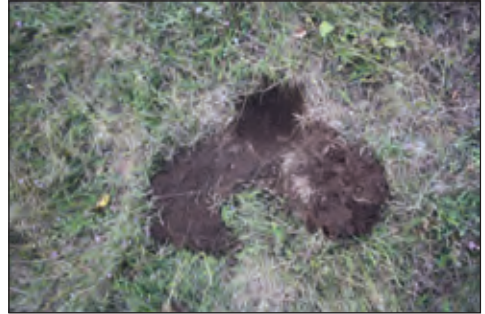
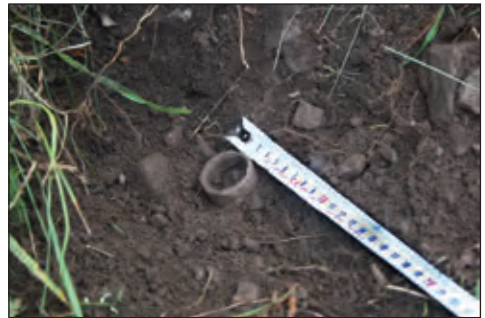
Figure 13. Detection equipment abandoned by poachers (a), seized metal detectors (b), poaching pits made in the fortress identified during on-site research (c-f). (photo by M-M Ciută, 2015).

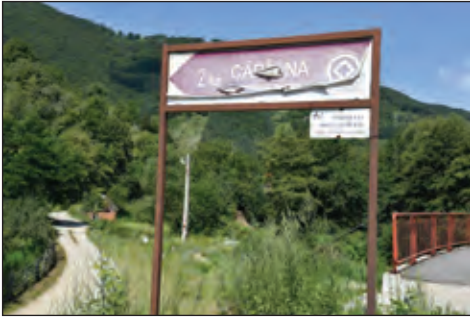
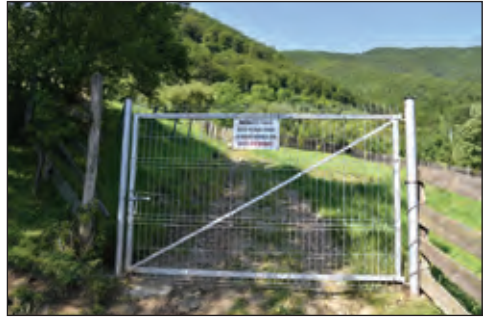
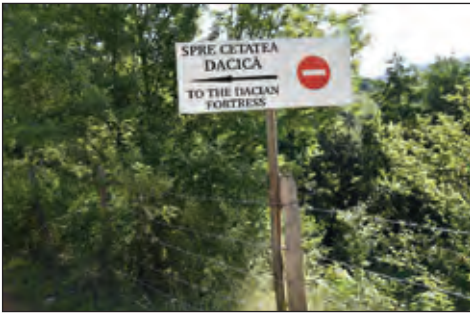
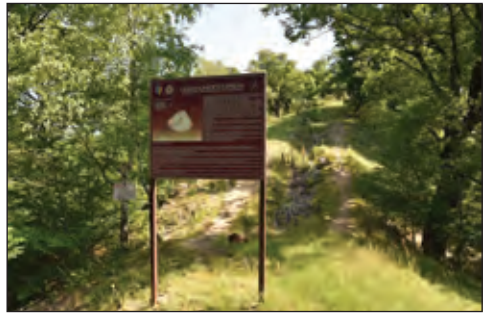
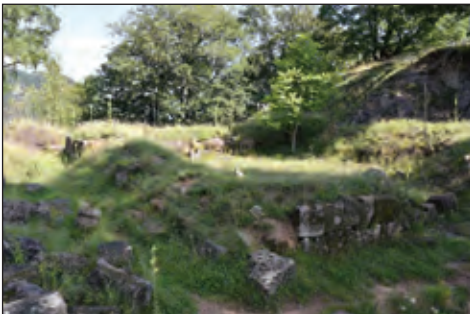
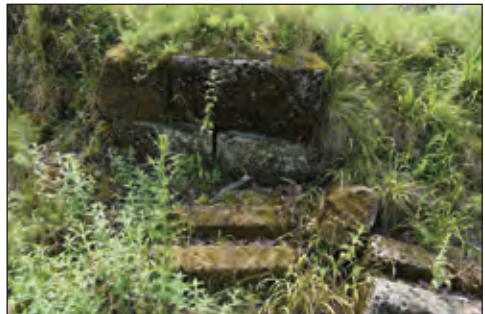
We also noted that the sign that marks the junction with the road climbing to the fortress was weather damaged and damaged through the passage of time (2006-2018!) (Figure 14). The unpleasant surprise came later, when we found that the access road on the northern side, from the Gărgălău valley, was no longer practicable for two reasons, mutually connected: it was covered by vegetation, as the owners of the earth plots overlapping the road decided to forbid access to their land, placing metal crossing gates provided with fastening systems (locks). Due to the fact that the local authorities took action, a compromise was reached, and these gates remained on the spot, being left open on weekends, when, supposedly, tourists would be visiting the fortress. This makes access to the fortress impossible to off-road vehicles, even partially and thus considerably extending the climbing time, to more than 40-50 minutes. The panel by the entrance to the fortress, though moved from its original place, is preserved much better, as it was positioned in the shadow. Inside, the fortress is the same, if not worse. Practically, since 2001, the archaeological poaching hole nearby the acropolis has remained unchanged, possibly slightly clogged, the fortress walls being even more collapsed, the square stone blocks being almost entirely covered by vegetation. Slowly, yet surely, only the entrance panel would mark with certainty the place where a fortress is in ruins, covered by ever winning vegetation and thus returning to circumstances before the 20th century.

Figure 14. Current outposts. Access road indicator (a), metallic gates forbidding car access to the UNESCO monument (b), pedestrian indicator towards the fortress (c), an explanatory panel with one of the old research unit (d), the current state of the fortress walls (e-f) (photo by S. Musteață 2018)
